LA-UR-21-27700

Title: Training Slides for Down Blending Data Collection

Inner container lid – condition to report

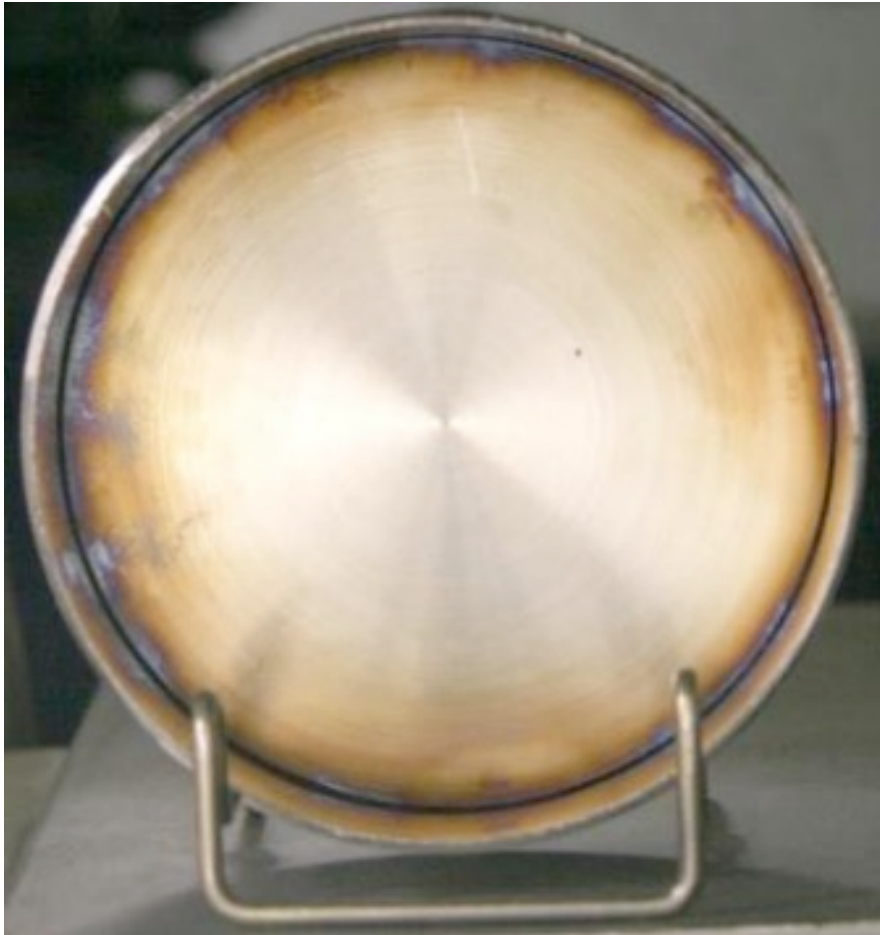
Features seen on container lids that are not to be reported

This container lid has features associated with the WHT that extend towards the center of the lid. But it lacks the ring of pitting corrosion. This lid is not to be reported.

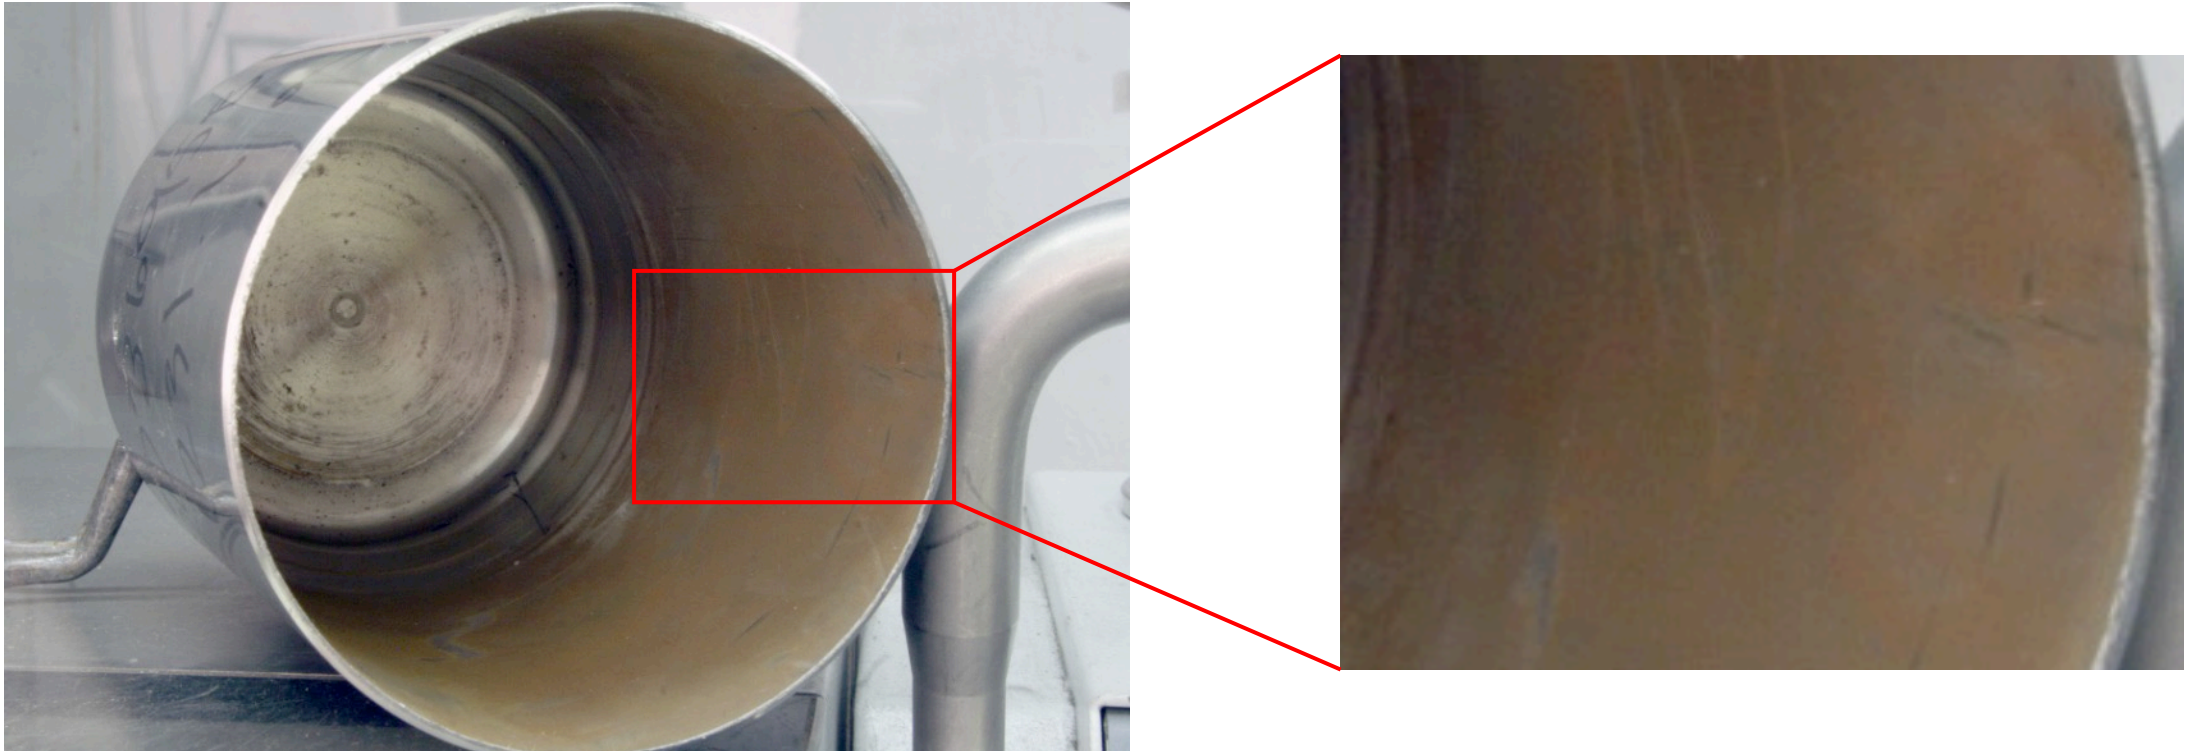
Inner container body – condition not to report

The inner wall of the inner container can have a coating of dust as shown in this image. This coating of dust without corrosion spots should not be reported.
